LED - Lampen Probleme

SEAMAID AFTER SALES SERVICE DIAGNOSTIC

PHOTO OF THE DAMAGED PRODUCT	DIAGNOSTIC	PROCEDURE

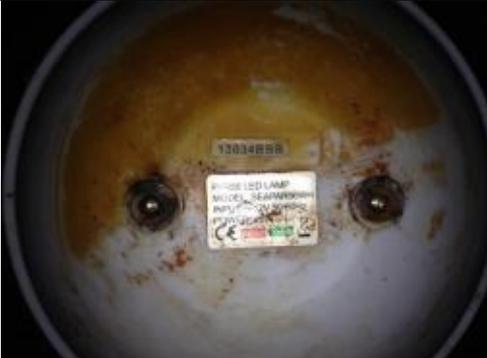
<p>Bad installation. Water is input by the rear portion of the lamp which is sealed. This creates a short-circuit.</p>	<p>The product is not under guarantee. Advise the customer to control the state of the joint and possibly change it.</p>

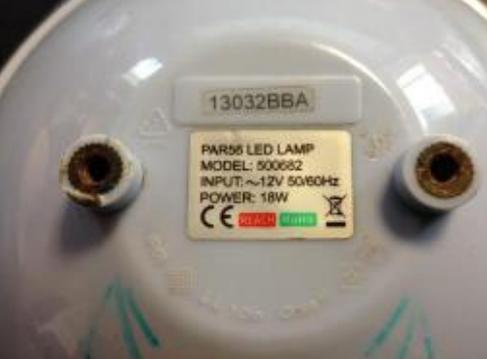
<p>If connectors are corroded without water traces, it means that the connection of the junction box is not sealed (water comes in by capillarity following the cable and arrives to the lamp) After a while, moisture settles by condensation and damages the lamp.</p>	<p>The product is not under guarantee. Advise the customer:</p> <ul style="list-style-type: none"> - To change the cable between the projector and the junction box - To make a sealed connection with resin, specific gel or other system. <p>If nothing is done, the problem will reappear</p>

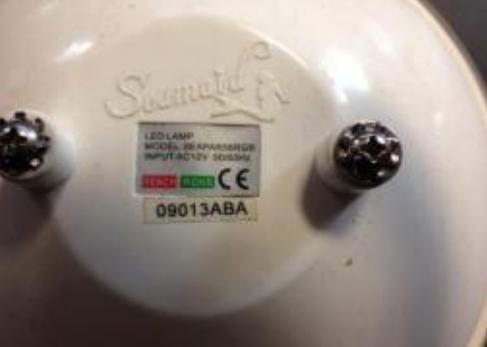
<p>On each product, there is a lot number. The first four numbers indicate the manufacturing date (e.g. 0901: manufactured in 2009, January)</p>	<p>All our products have a 2 year guarantee. Products which are older than 2 years will have to prove by the final customer's bill that they have less than 2 years of use.</p>

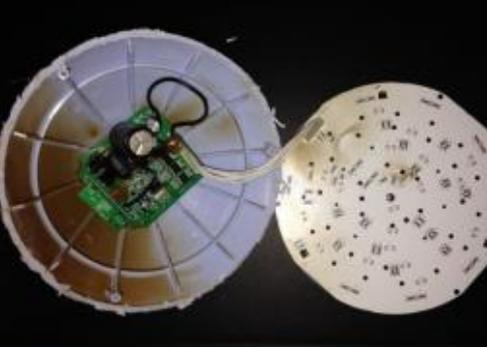
<p>In this case, the lamp had an overvoltage because of :</p> <ul style="list-style-type: none"> - Direct connection on 230V - Connection on a transformer over 12V - The 230V / 12V transformer of the installation is defective and has damaged the projector - Overvoltage caused by an electrical overload due to an exceptional event 	<p>It is very difficult to see the problem without opening the product. In this case, you must send the product back to us to be checked. If it is an overvoltage the product will not be under guarantee. Before replacing the lamp, check the voltage with a voltmeter at the output of the transformer.</p>
